February 20, 2025

ARBORIST REPORT

1095 Kingston Road, Pickering, Ontario

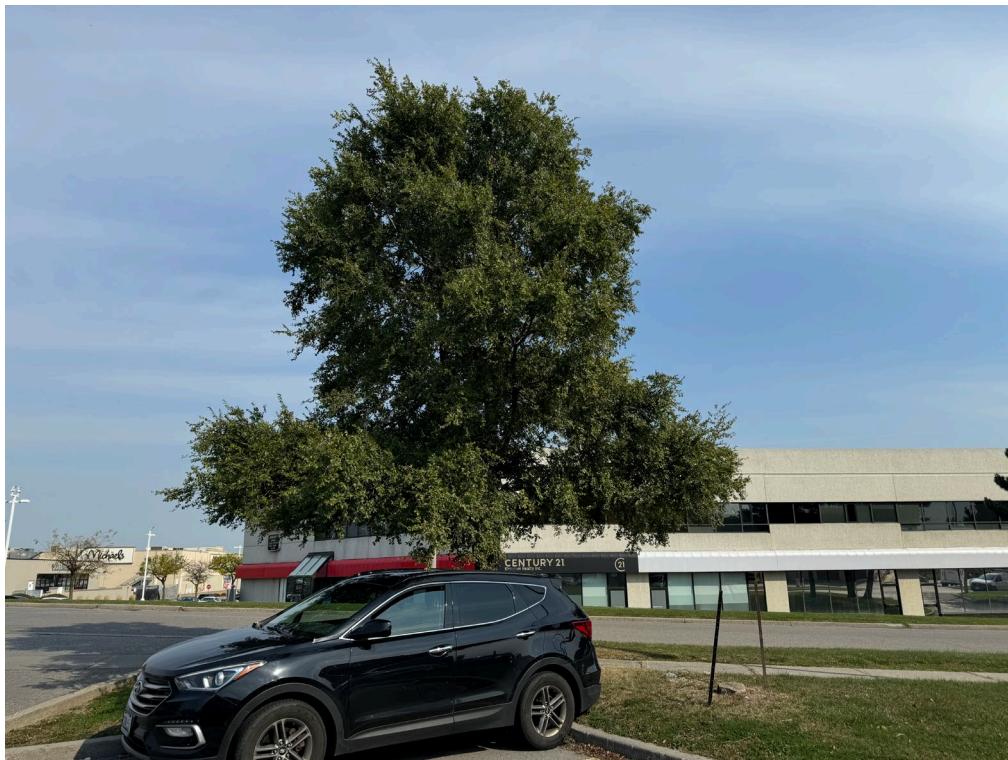
Tree 152

Tree #	Common Name	Botanical Name	DBH (CM)	Condition	Comments	Recommendation
152	Siberian Elm	<i>Ulmus pumila</i>	34	F		Remove due to construction
153	Manitoba Maple	<i>Acer negundo</i>	10	F	Multi-stem	Remove due to construction
154	Manitoba Maple	<i>Acer negundo</i>	17	F	Multi-stem	Remove due to construction
155	Colorado Blue Spruce	<i>Picea pungens</i> var. <i>glauca</i>	17	D	Tree is 100% dead	Remove due to construction
156	Colorado Blue Spruce	<i>Picea pungens</i> var. <i>glauca</i>	25	F	Minor deadwood throughout	Remove due to construction
157	Colorado Blue Spruce	<i>Picea pungens</i> var. <i>glauca</i>	27	F		Remove due to construction
158	Colorado Blue Spruce	<i>Picea pungens</i> var. <i>glauca</i>	26	F		Remove due to construction
159	Black Walnut	<i>Juglans nigra</i>	7	F	2 stem at 0.1m	Remove due to construction
160	Norway Maple	<i>Acer platanoides</i>	31	F	Minor to moderate deadwood throughout, tar spots	Remove due to construction

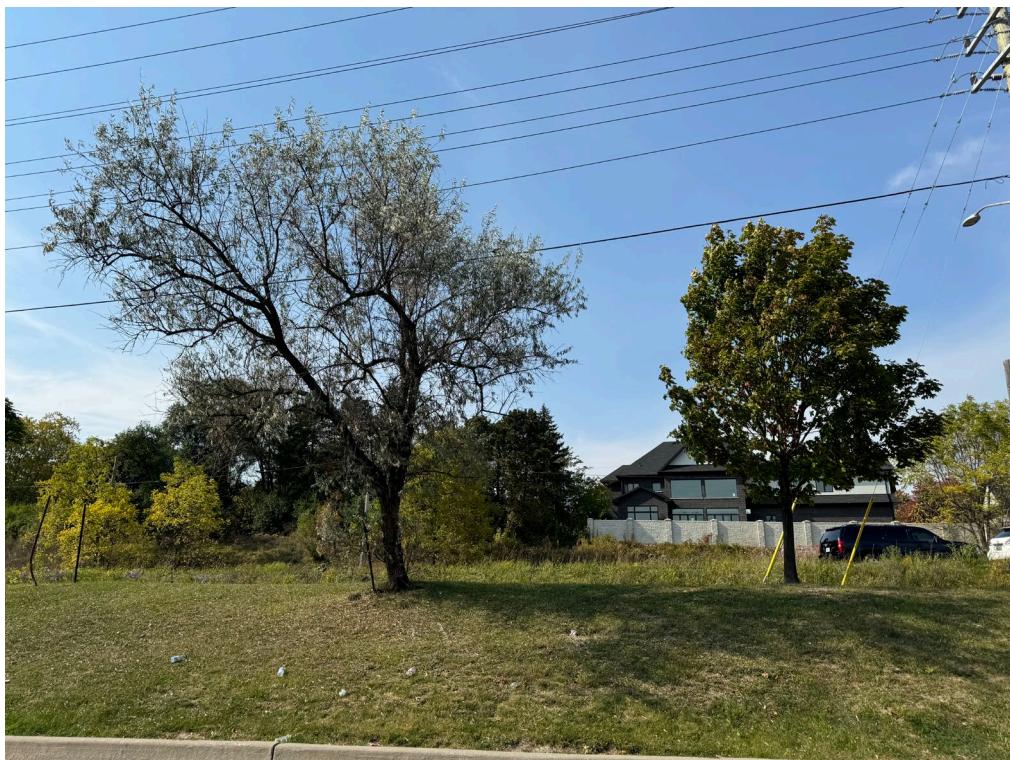
Trees 161, 162

161	Norway Maple	<i>Acer platanoides</i>	18	F		Remove due to construction
162	Russian Olive	<i>Elaeagnus angustifolia</i>	28	F	Minor deadwood throughout	Remove due to construction
163	Norway Maple	<i>Acer platanoides</i>	13	F	Tar spots	Remove due to construction
164	Colorado Blue Spruce	<i>Picea pungens</i> var. <i>glauca</i>	24	F/G		Remove due to construction
165	Russian Olive	<i>Elaeagnus angustifolia</i>	19	F	Significant lean, minor deadwood throughout	Remove due to construction
166	Russian Olive	<i>Elaeagnus angustifolia</i>	28	F	Mild lean, minor deadwood throughout	Remove due to construction

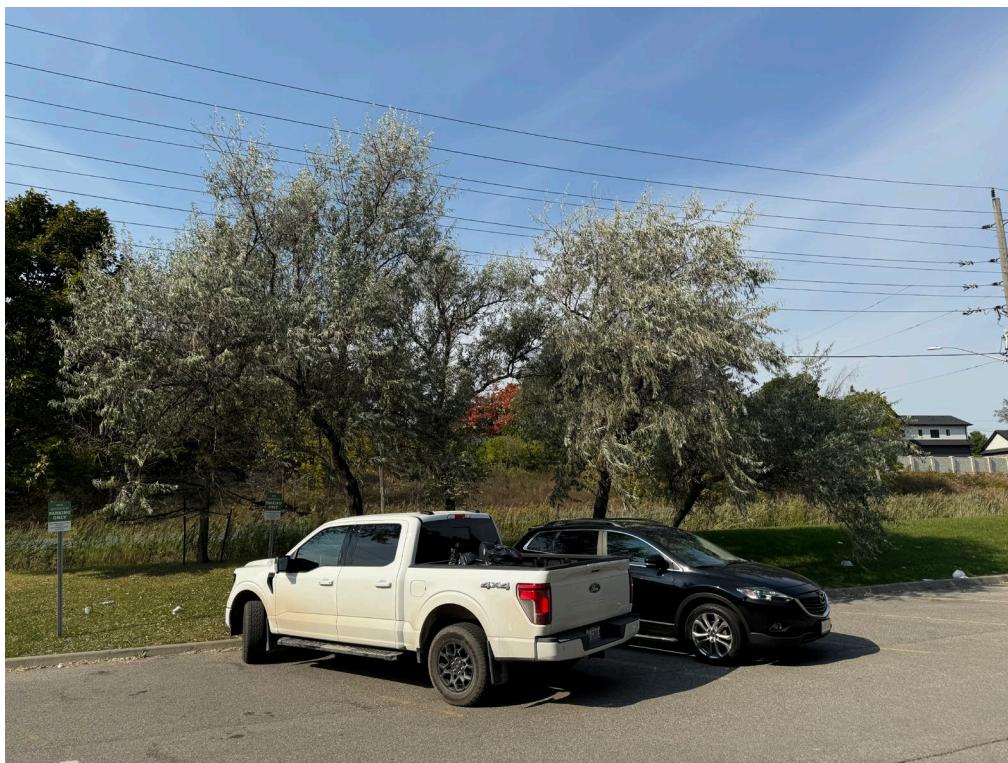
Trees 165 – 168

167	Russian Olive	<i>Elaeagnus angustifolia</i>	23	F	Minor deadwood throughout	Remove due to construction
168	Russian Olive	<i>Elaeagnus angustifolia</i>	28	F	Minor deadwood throughout	Remove due to construction
169	White Spruce	<i>Picea glauca</i>	15	P	Moderate to significant deadwood throughout	Remove due to construction
170	Norway Maple	<i>Acer platanoides</i>	27	F	Tar spots	Remove due to construction
171	Russian Olive	<i>Elaeagnus angustifolia</i>	29	F	Minor deadwood throughout	Remove due to construction
172	Norway Maple	<i>Acer platanoides</i>	27	F	Tar spots	Remove due to construction
173	Colorado Blue Spruce	<i>Picea pungens var. glauca</i>	21	F/P	Minor deadwood throughout	Remove due to construction
174	Colorado Blue Spruce	<i>Picea pungens var. glauca</i>	22	F		Remove due to construction
175	Norway Maple	<i>Acer platanoides</i>	23	F	Previously topped	Remove due to construction
176	Colorado Blue Spruce	<i>Picea pungens var. glauca</i>	12	F/G		Remove due to construction

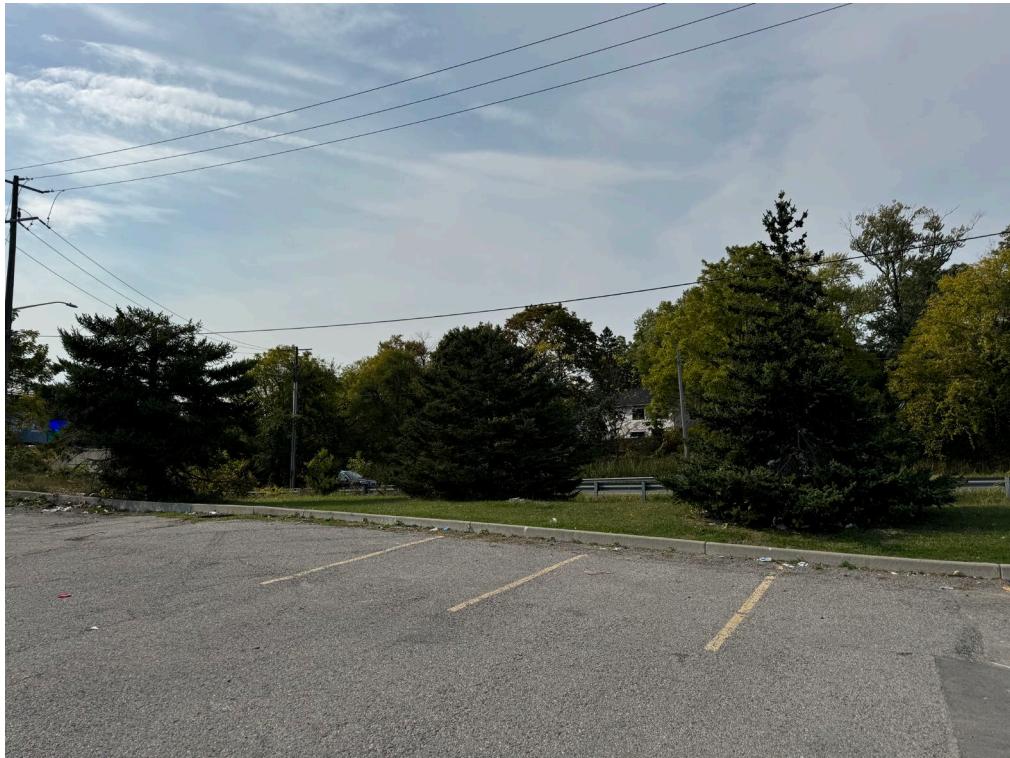
Trees 176 – 178

177	Colorado Blue Spruce	<i>Picea pungens var. glauca</i>	19	F	Previously topped	Remove due to construction
178	Colorado Blue Spruce	<i>Picea pungens var. glauca</i>	24	F	Previously topped	Retain
179	Black Locust	<i>Robinia pseudoacacia</i>	38	F/P	Moderate deadwood throughout, multi-stem	Retain
180	American Elm	<i>Ulmus americana</i>	20	F		Retain
181	Norway Maple	<i>Acer platanoides</i>	27	F/P	Minor to moderate deadwood in canopy, tar spots	Retain
182	Norway Maple	<i>Acer platanoides</i>	31	F/P	Minor deadwood in canopy, tar spots	Retain
O1	Juniper	<i>Juniperus</i>	~13	F	Mild lean	Retain
O2	Black Locust	<i>Robinia pseudoacacia</i>	~10	F	Multi-stem	Retain
