December 20, 2024

**ARBORIST REPORT**  
375 Kingston Road, Pickering, Ontario

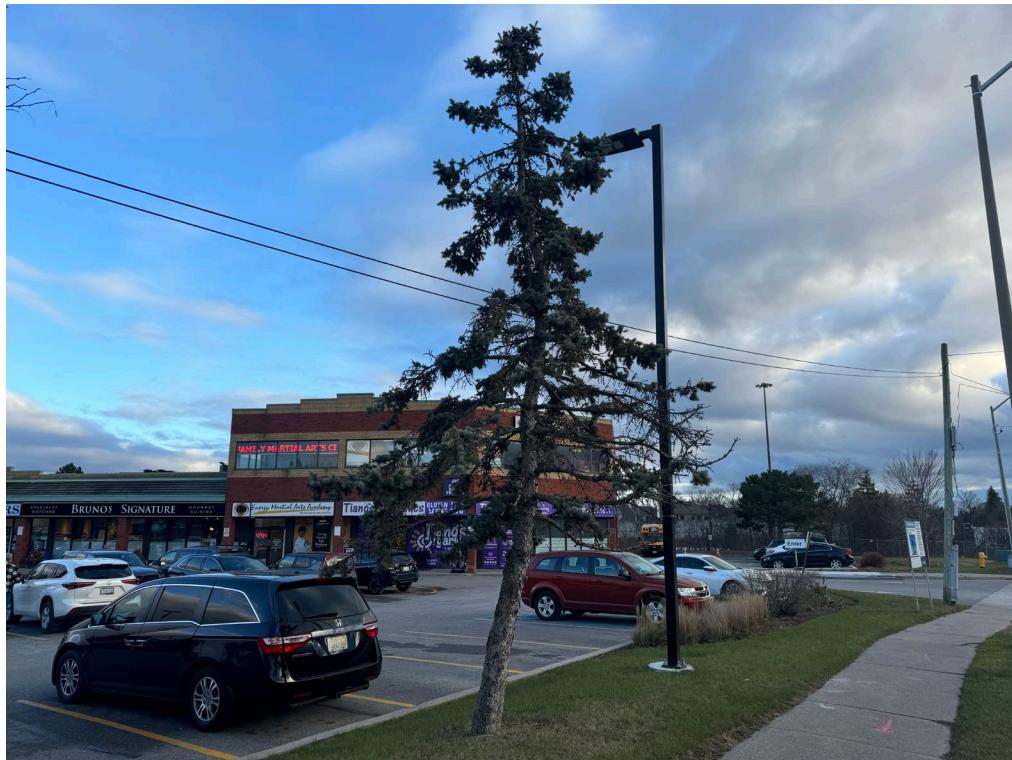
Tree 163

Tree #	Common Name	Botanical Name	DBH (CM)	Canopy (M)	Condition	Structure	Comments	Recommendation
163	Colorado Blue Spruce	<i>Picea pungens</i> var. <i>glauca</i>	23	3	F/P	P	Moderate/significant bow in trunk, Moderate/significant needle drop	Remove due to construction
164	Honey Locust	<i>Gleditsia triacanthos</i>	24	6	F	F	Mild bow in trunk	Remove due to construction
165	Honey Locust	<i>Gleditsia triacanthos</i>	33	12	F	F		Remove due to construction
166	Colorado Blue Spruce	<i>Picea pungens</i> var. <i>glauca</i>	17	-	D	-	Previously removed	Remove due to condition
167	Colorado Blue Spruce	<i>Picea pungens</i> var. <i>glauca</i>	28	5	F/P	P	Previously removed	Remove due to construction
168	Honey Locust	<i>Gleditsia triacanthos</i>	29	9	F	F	Non-ideal form, Conflicting with hydro line	Remove due to construction
169	Honey Locust	<i>Gleditsia triacanthos</i>	29	9	F	F	Conflicting with hydro line, conflicting with light standard	Remove due to construction

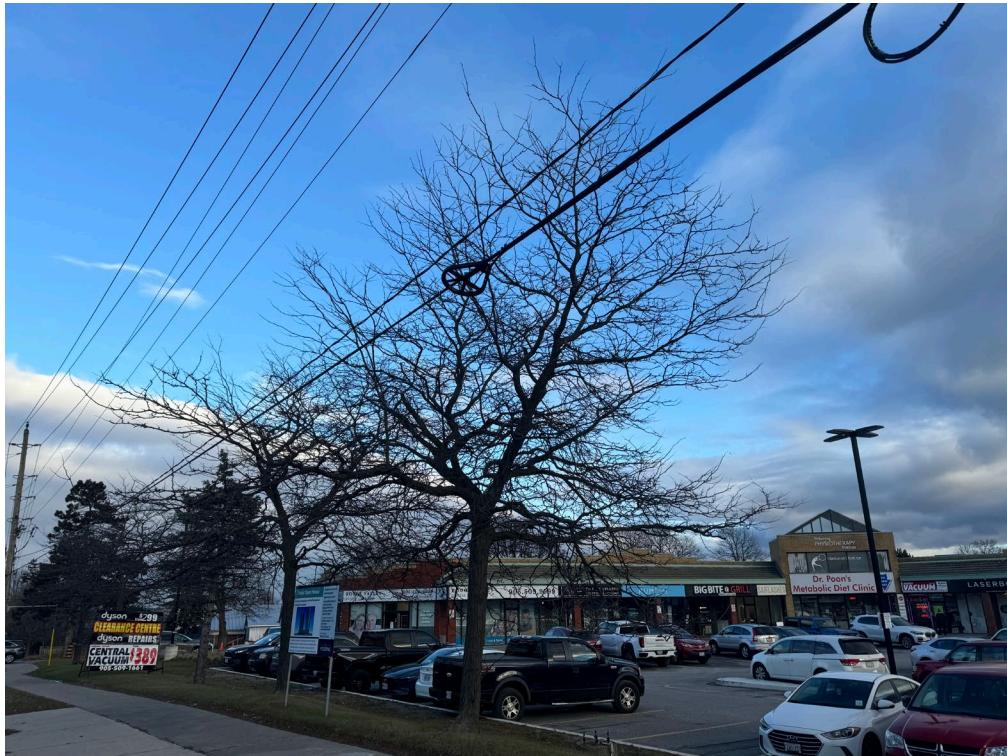
Trees 169, 170

170	Honey Locust	<i>Gleditsia triacanthos</i>	26	8	F	F	Conflicting with hydro line	Remove due to construction
171	Colorado Blue Spruce	<i>Picea pungens</i> var. <i>glauca</i>	24	5	P	F/P	Moderate/significant needle drop	Remove due to construction
172	Honey Locust	<i>Gleditsia triacanthos</i>	25	8	F	F	Conflicting with hydro line	Remove due to construction
173	Honey Locust	<i>Gleditsia triacanthos</i>	24	8	F	F	Conflicting with hydro line	Remove due to construction
174	Colorado Blue Spruce	<i>Picea pungens</i> var. <i>glauca</i>	23	5	D	-	Tree is 100% dead	Remove due to construction

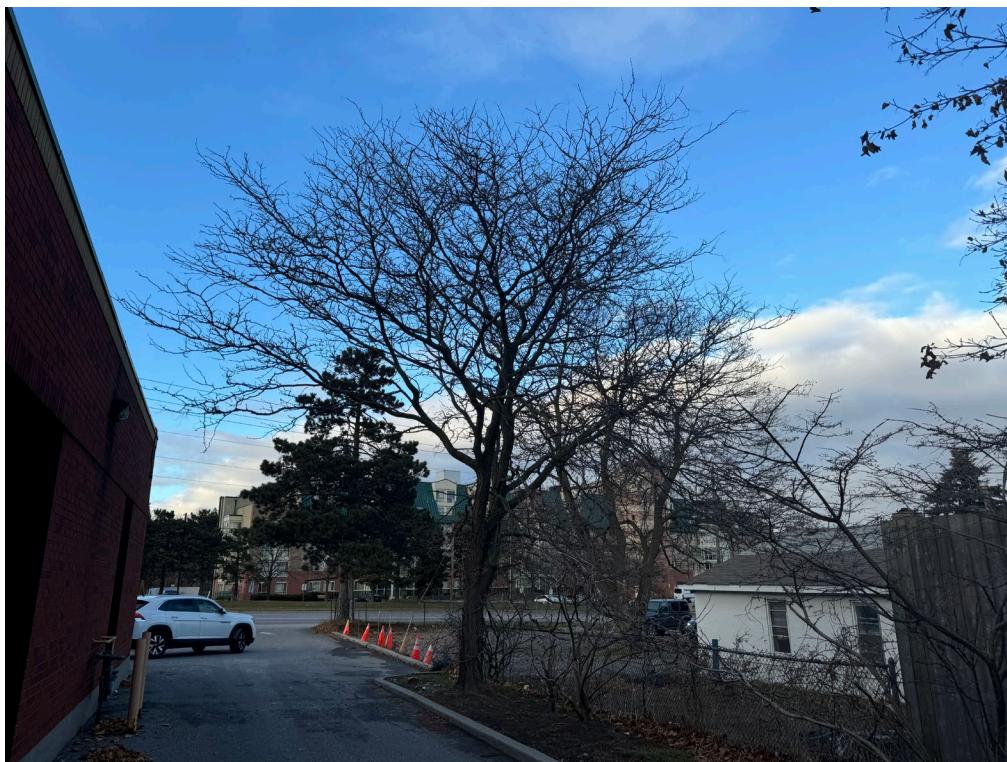
Tree 175

175	Honey Locust	<i>Gleditsia triacanthos</i>	39	14	F	P	Significant structural failure evident	Remove due to construction
176	Norway Maple	<i>Acer platanoides</i>	47	18	F	F	Moderate root growing below root flare	Remove due to construction
177	Norway Maple	<i>Acer platanoides</i>	35	16	F	F		Remove due to construction
178	Norway Maple	<i>Acer platanoides</i>	31	15	F	F	3 stems at 0.3m, bowed trunks	Remove due to construction
179	Norway Maple	<i>Acer platanoides</i>	36	16	F	F	Co-dominant leaders, callousing wound at 1.0m	Remove due to construction
180	Austrian Pine	<i>Pinus nigra</i>	33	11	F	F/P	Moderate/significant bow in trunk and upper structure	Remove due to construction
181	Austrian Pine	<i>Pinus nigra</i>	32	12	F/G	F		Remove due to construction
182	Austrian Pine	<i>Pinus nigra</i>	31	10	F	F/P	Moderate bow in trunk(phototrophic related)	Remove due to construction
183	Austrian Pine	<i>Pinus nigra</i>	34	11	F	F	Mild/moderate lean	Remove due to construction

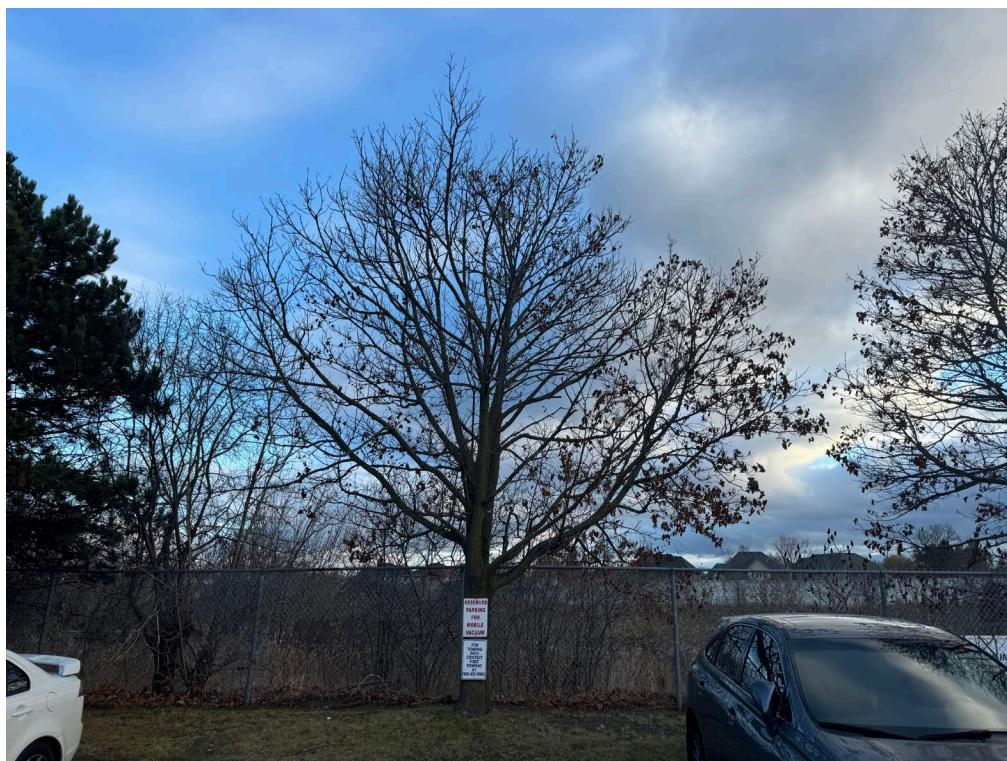
Tree 184

184	Norway Maple	<i>Acer platanoides</i>	33	8	F	F	Parking signs nailed to tree	Remove due to construction
185	Norway Maple	<i>Acer platanoides</i>	28	7	F	F	Mild dead wood in canopy	Remove due to construction
186	Norway Maple	<i>Acer platanoides</i>	25	7	F	F	Moderate dead wood in canopy	Remove due to construction
187	Norway Maple	<i>Acer platanoides</i>	18	6	P	P	Significant dead wood in canopy, Significant rot within trunk	Remove due to construction
188	Norway Maple	<i>Acer platanoides</i>	24	8	F	F	Mild dead wood in canopy	Remove due to construction
189	Austrian Pine	<i>Pinus nigra</i>	31	-	D	-	Tree is 100% dead	Remove due to condition
190	Austrian Pine	<i>Pinus nigra</i>	21	-	D	-	Previously removed	Remove due to condition
191	Austrian Pine	<i>Pinus nigra</i>	34	12	F	F		Remove due to construction
192	Austrian Pine	<i>Pinus nigra</i>	36	13	F	F		Remove due to construction
193	Freemanii Maple	<i>Acer Freemanii</i>	6	2	F/G	G		Remove due to construction

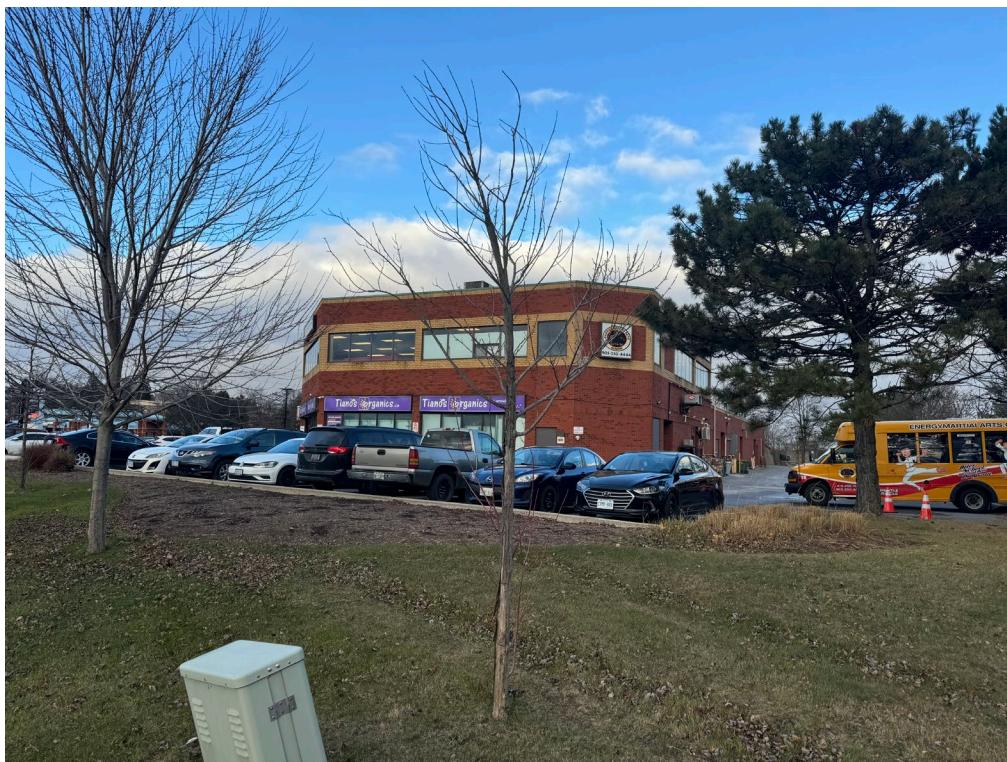
Tree 194

194	Freemanii Maple	<i>Acer Freemanii</i>	7	2	F	F	Significant damage above root flare	Remove due to construction

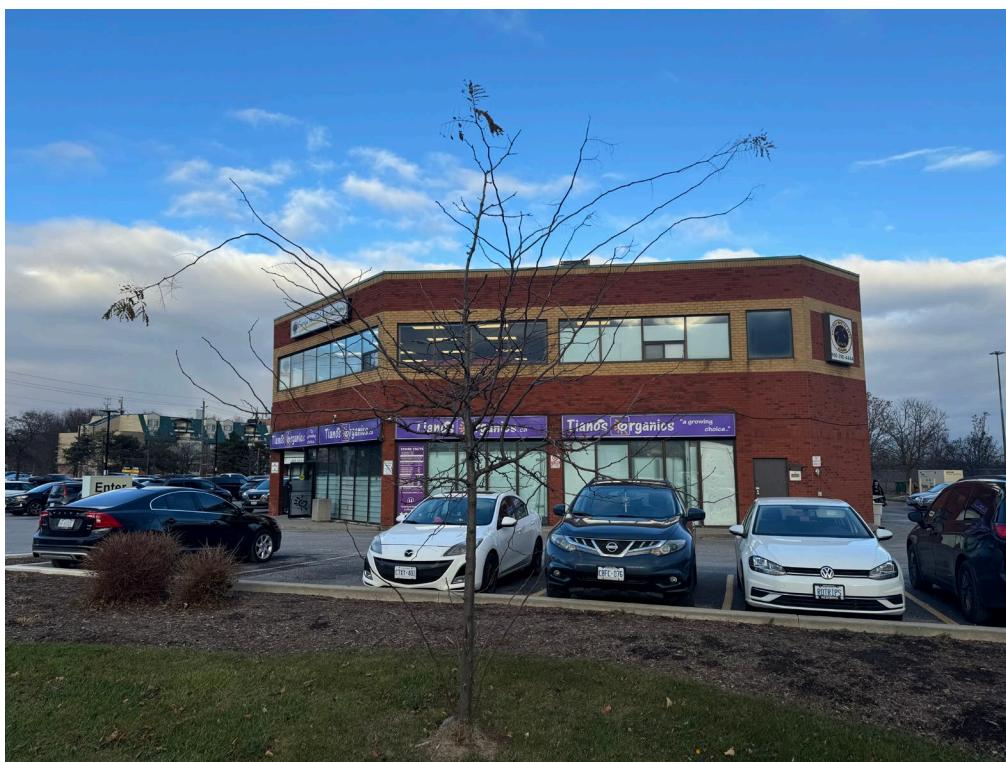
Tree 196

195	Freemanii Maple	Acer Freemanii	19	3	F/G	G		Remove due to construction
196	Honey Locust	Gleditsia triacanthos	7	2	F	F	Exposed roots	Remove due to construction
443	Norway Maple	Acer platanoides	103	14	F/P	P	Cavity in trunk, significant internal rot, major limbs previously removed, suspected significant failure risk	Remove due to construction
444	Norway Maple	Acer platanoides	29	8	F	F	Previous limb failure	Remove due to construction
445	Norway Maple	Acer platanoides	32	8	F	F/P	Shallow roots, significant root girdling	Remove due to construction
446	Colorado Blue Spruce	Picea pungens var. glauca	46	6	F	F		Remove due to construction
447	Honey Locust	Gleditsia triacanthos	19	8	F	F	Suckers at base	Remove due to construction
448	Manitoba Maple	Acer negundo	35	10	F	F/P	Moderate lean, growing through fence	Remove due to construction
449	Manitoba Maple	Acer negundo	21	12	F	F/P	Multi-stem, growing through fence	Remove due to construction

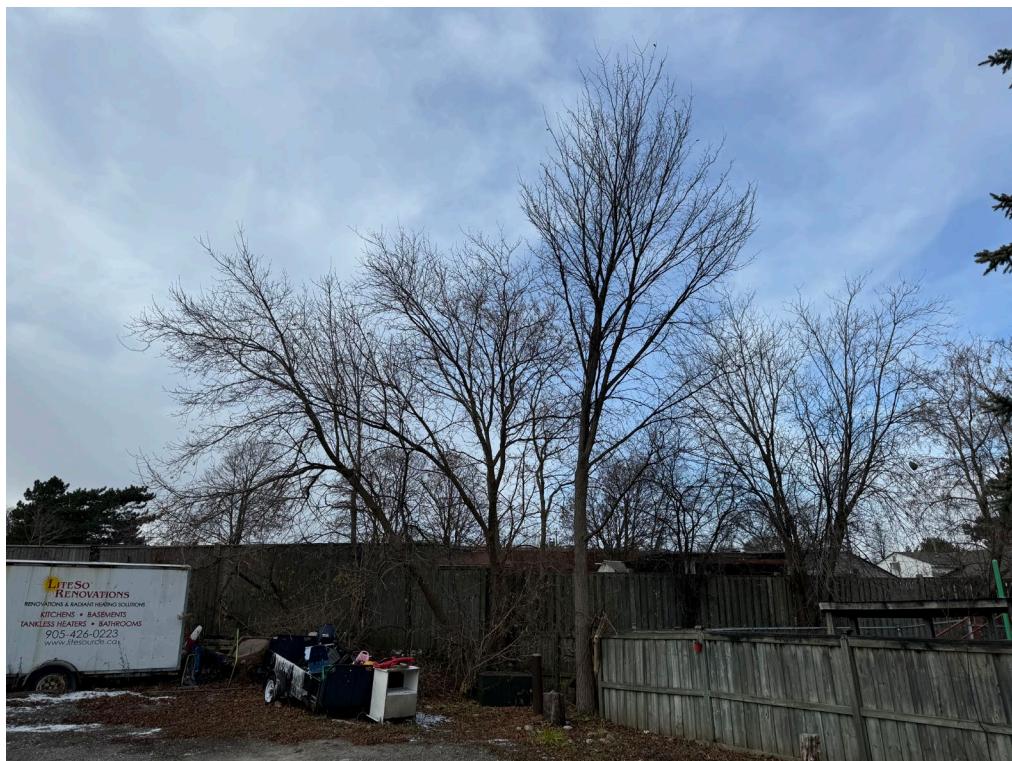
Trees 450 – 452

450	Manitoba Maple	Acer negundo	21	9	F	F/P	Multi-stem, growing through fence	Remove due to construction
451	Manitoba Maple	Acer negundo	21	11	F	F	Multi-stem, moderate lean	Remove due to construction
452	American Elm	Ulmus americana	29	7	F	F		Remove due to construction
453	Colorado Blue Spruce	Picea pungens var. glauca	38	8	F	F		Remove due to construction
454	Manitoba Maple	Acer negundo	16	5	F	F		Remove due to construction
455	Austrian Pine	Pinus nigra	20	6	F	F	2 stem at 1.0 metre	Remove due to construction
456	Sugar Maple	Acer saccharum	43	12	F	F		Retain
457	Buckthorn	Rhamnus cathartica	26	9	F	F	Multi-stem, mild to moderate lean	Retain
458	Japanese Red Maple	Acer palmatum	12	9	F	F		Retain
459	Norway Maple	Acer platanoides	69	15	F	F	Shallow roots	Retain

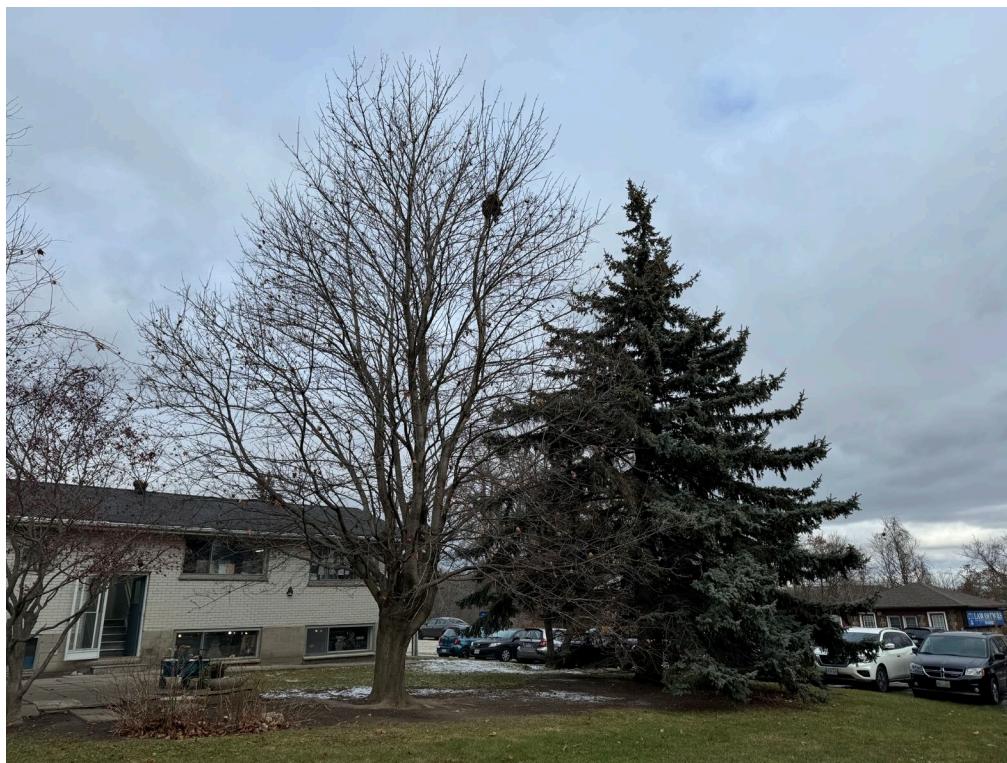
Trees 459, 460

460	Colorado Blue Spruce	<i>Picea pungens</i> var. <i>glauca</i>	51	12	F	F	Minor deadwood throughout	Retain
461	Manitoba Maple	<i>Acer negundo</i>	19	7	F	F	Moderate lean, 2 stem at 0.9 metres	Retain
462	Manitoba Maple	<i>Acer negundo</i>	26	8	F	F		Retain
463	Flowering Crabapple Tree	Malus Sp.	30	9	F	F	2 stem at 1.3 metres	Retain
464	Manitoba Maple	<i>Acer negundo</i>	91	16	F	F	Signs of internal rot	Remove due to construction
465	Austrian Pine	<i>Pinus nigra</i>	13	4	F	F		Remove due to construction
466	Austrian Pine	<i>Pinus nigra</i>	24	7	F	F		Remove due to construction
467	Austrian Pine	<i>Pinus nigra</i>	12	4	F	F	Minor deadwood in canopy	Retain
468	Honey Locust	<i>Gleditsia triacanthos</i>	30	15	F	F		Retain
469	Honey Locust	<i>Gleditsia triacanthos</i>	30	12	F	F		Remove due to construction
470	Colorado Blue Spruce	<i>Picea pungens</i> var. <i>glauca</i>	20	3	F/P	F	Minor to moderate deadwood throughout	Remove due to construction

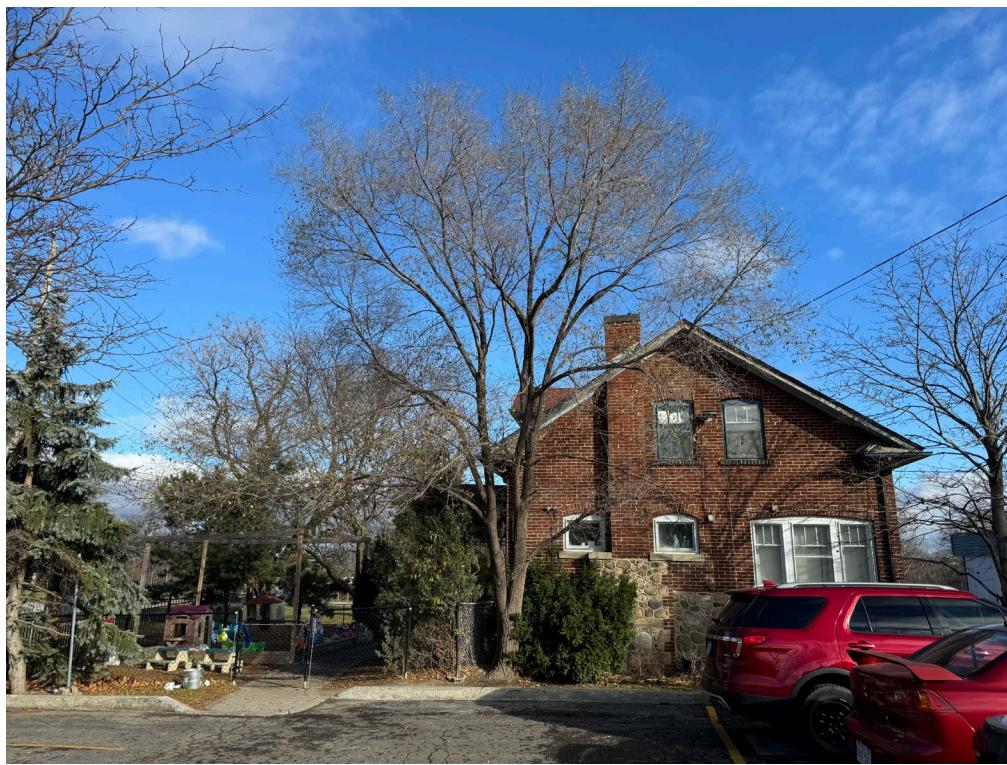
Tree 472

471	Colorado Blue Spruce	<i>Picea pungens</i> var. <i>glauca</i>	18	3	F	F		Remove due to construction
472	Siberian Elm	<i>Ulmus pumila</i>	44	11	F	F	2 stem at 1.5 metres	Remove due to construction
473	Norway Maple	<i>Acer platanoides</i>	26	6	F	F		Remove due to construction
474	Norway Maple	<i>Acer platanoides</i>	33	7	F	F		Remove due to construction
475	Norway Maple	<i>Acer platanoides</i>	27	6	F	F		Remove due to construction
476	Norway Maple	<i>Acer platanoides</i>	34	6	F	F		Remove due to construction
O1	Austrian Pine	<i>Pinus nigra</i>	~45	17	F/G	F/G		Remove due to construction
O2	Manitoba Maple	<i>Acer negundo</i>	~20	7	F	F		Remove due to construction
O3	Manitoba Maple	<i>Acer negundo</i>	~40	13	F/P	P	Previously removed	Remove due to construction

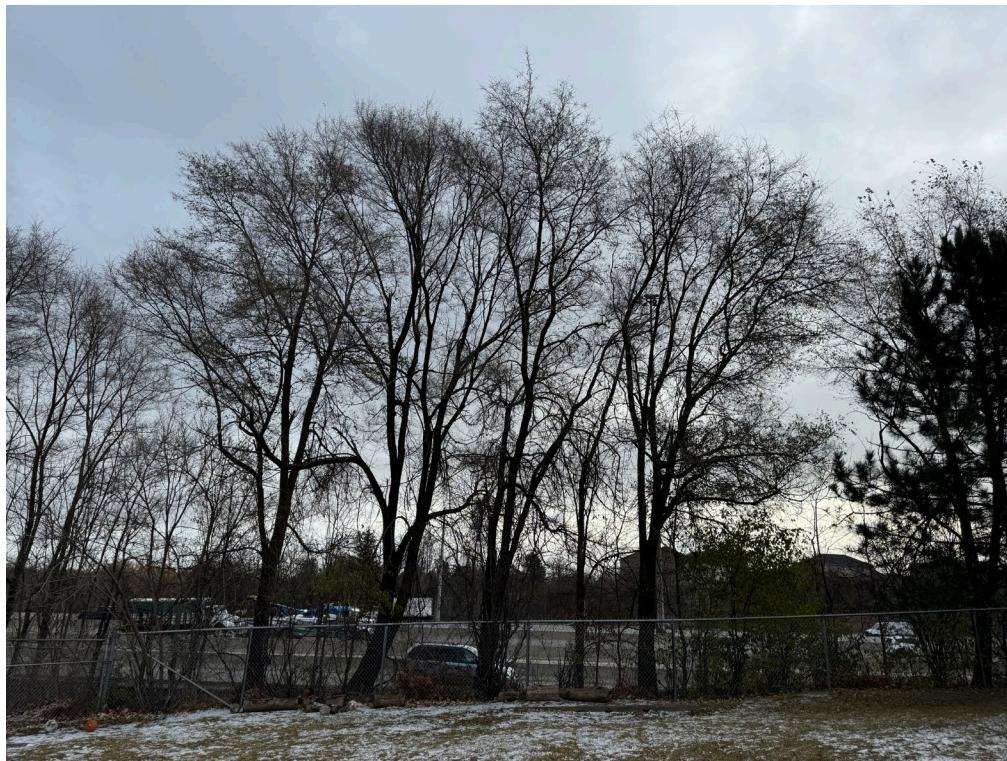
Trees O11 – O14

O4	Manitoba Maple	Acer negundo	~15	5	F	P	Poor form	Retain
O5	Manitoba Maple	Acer negundo	~27	9	F/P	P	Poor form, fruiting bodies evident	Retain
O6	Colorado Spruce	Picea pungens	~25	8	F/G	F		Retain
O7	Colorado Spruce	Picea pungens	~25	7	F/G	F		Retain
O8	Colorado Spruce	Picea pungens	~25	7	F/G	F		Retain
O9	Siberian Elm	Ulmus pumila	~26	8	F	F		Retain
O10	Siberian Elm	Ulmus pumila	~29	10	F	F		Retain
O11	Siberian Elm	Ulmus pumila	~34	12	F	F		Retain
O12	Siberian Elm	Ulmus pumila	~23	8	F	F		Retain
O13	Siberian Elm	Ulmus pumila	~52	13	F	F	Mild lean	Retain
O14	Siberian Elm	Ulmus pumila	~36	11	F	F		Retain
