December 20, 2024

**ARBORIST REPORT**  
375 Kingston Road, Pickering, Ontario

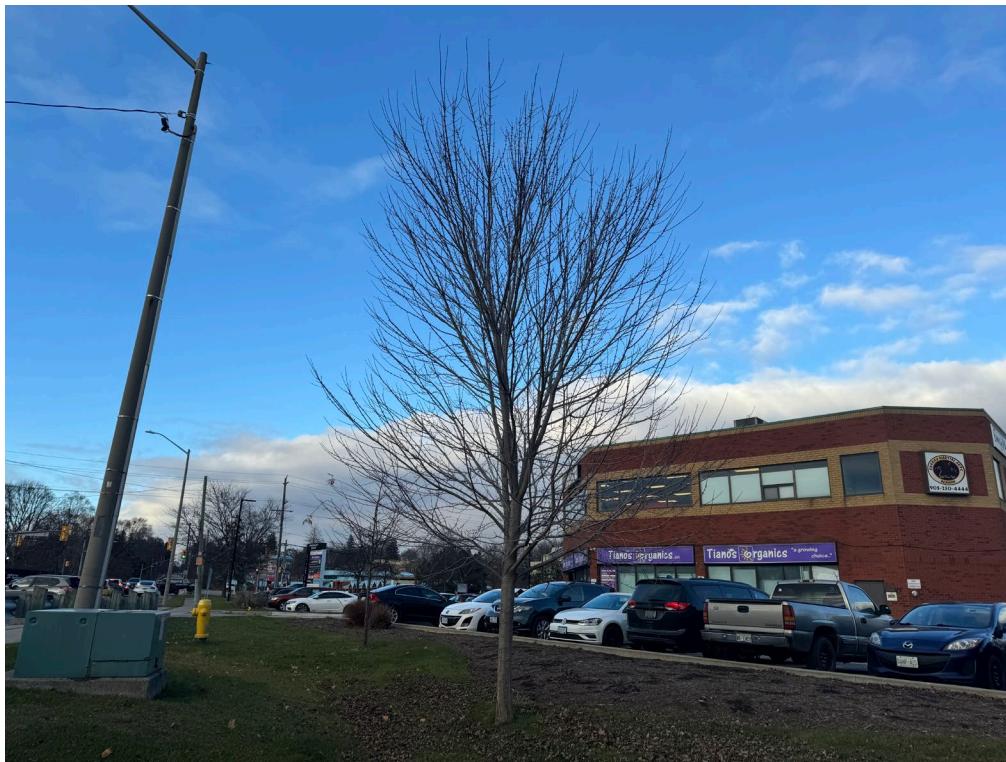
Tree 195

195	Freemanii Maple	Acer Freemanii	19	3	F/G	G		Remove due to construction
196	Honey Locust	Gleditsia triacanthos	7	2	F	F	Exposed roots	Remove due to construction
443	Norway Maple	Acer platanoides	103	14	F/P	P	Cavity in trunk, significant internal rot, major limbs previously removed, suspected significant failure risk	Remove due to construction
444	Norway Maple	Acer platanoides	29	8	F	F	Previous limb failure	Remove due to construction
445	Norway Maple	Acer platanoides	32	8	F	F/P	Shallow roots, significant root girdling	Remove due to construction
446	Colorado Blue Spruce	Picea pungens var. glauca	46	6	F	F		Remove due to construction
447	Honey Locust	Gleditsia triacanthos	19	8	F	F	Suckers at base	Remove due to construction
448	Manitoba Maple	Acer negundo	35	10	F	F/P	Moderate lean, growing through fence	Remove due to construction
449	Manitoba Maple	Acer negundo	21	12	F	F/P	Multi-stem, growing through fence	Remove due to construction
